PROBLEM SOLVING APPLICATIONS

Continuous Casting Foundation Instability

PRES, Inc. was asked to investigate the cause of the deterioration on a continuous casting foundation at a steel mill in May of 2001. Vibration data was collected via a Sentry ICMS.

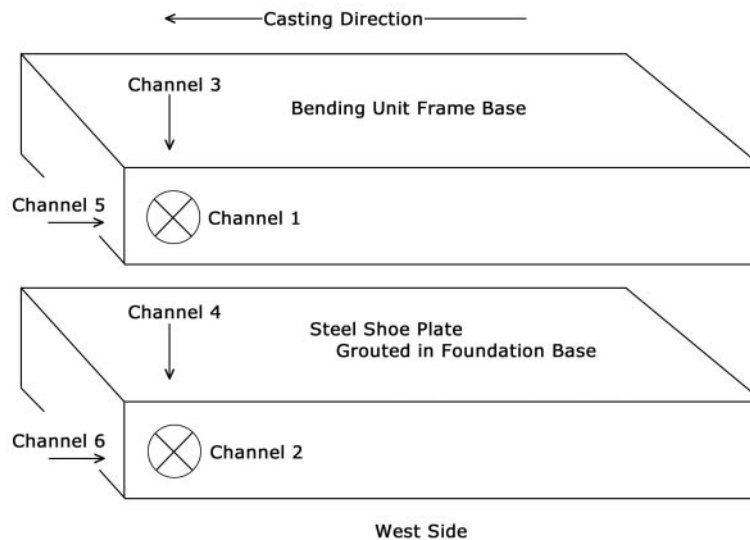
Figure 1: Accelerometers were strategically placed on the bending unit frame and steel shoe plate that were fastened to the concrete foundations. Observations, data collection, and analysis were then made to determine the root cause of the concrete foundation deterioration under each shoe plate.

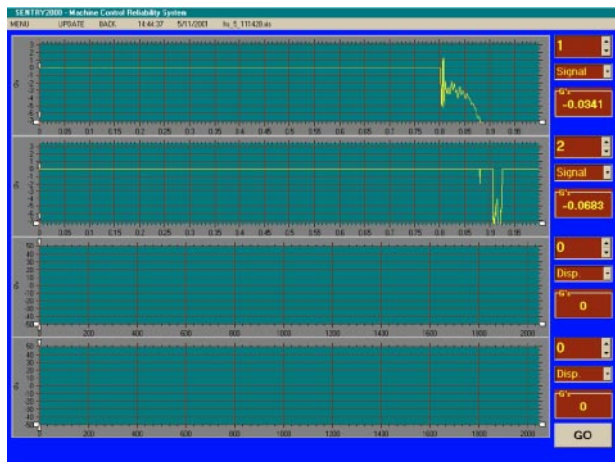
Figure 2: Time waveform Channels 1 & 2 during shear impacting. This graph illustrates that vibration resulting from the shears are much greater than steady-state vibrations. It illustrates how channel 1 "ring" for several seconds transmitting large amounts of vibration energy to the structure shoe plate and subsequently the foundation (see Channel #2). Although channel #2 does not "ring" like channel #1, the vibration energy is transmitted to the foundation.

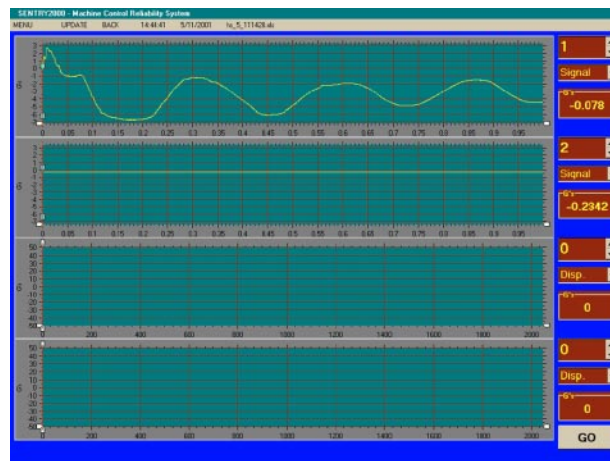
Figure 3: Time waveform depicting channel #1 "ringing" note: This waveform was obtained 4 seconds after Figure #3. PRES Inc. suggested that damping the vibration transmitted to the shoe plate would prevent the structural deterioration currently effecting the concrete structure. One damping possibility could be the insulation of the bending unit main frame from the shoe plate.
